Patch Release Note

Patch 86251-08 For Rapier Series Switches

This patch release note lists the issues addressed and enhancements made in patch 86251-08 for Software Release 2.5.1 on existing models of Rapier L3 managed switches. Patch file details are listed in Table 1.

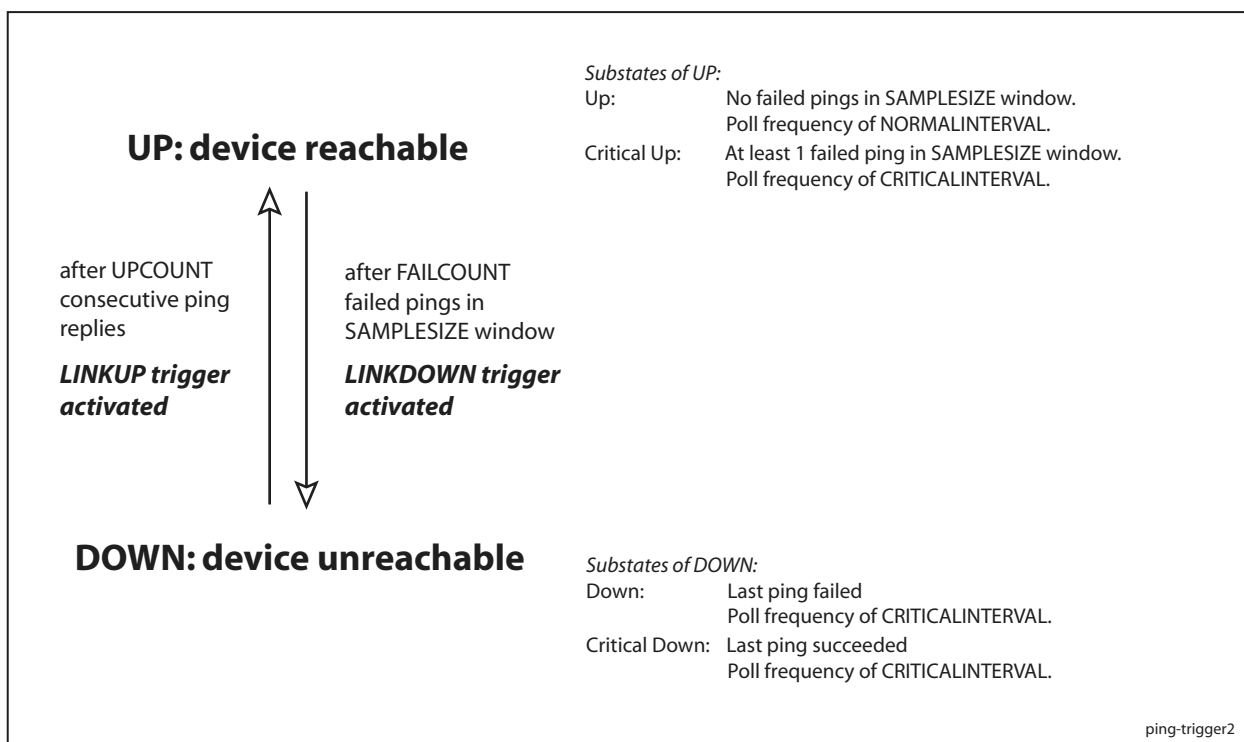
Figure 3: The interaction between states and parameters for ping polling.

The number of pings that the router or switch will examine to consider a change in state is controlled by three parameters: FAILCOUNT, SAMPLESIZE, and UPCOUNT. The FAILCOUNT is the number of pings that must be unanswered for the router or switch to consider the device unreachable. The default is 5. The SAMPLESIZE is the total number of pings within which the FAILCOUNT number of pings must be unanswered. If SAMPLESIZE and FAILCOUNT are the same, the unanswered pings must be consecutive. If SAMPLESIZE is greater than FAILCOUNT, a device that does not always reply to pings may be declared unreachable. By default, SAMPLESIZE is equal to FAILCOUNT. The UPCOUNT is the number of consecutive pings that must be answered for the router or switch to consider the device reachable again. The default is 30. The interaction between these parameters is shown in Figure 3.

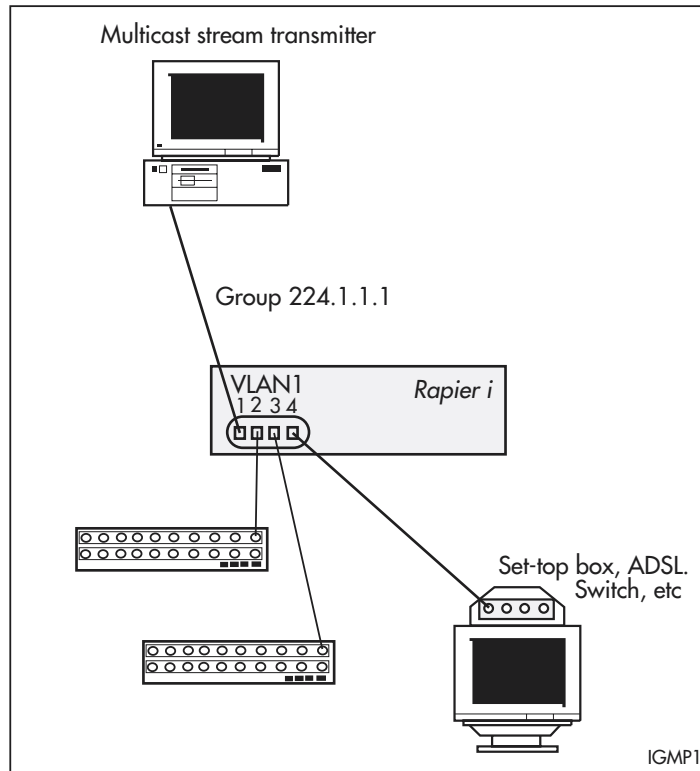
Figure 6: Forwarding multicast data over a specified interface and port.

Currently the switch forwards multicast data on a dynamic basis to hosts who have joined the multicast group. This enhancement allows the user to instruct the switch to forward multicast data over a specified interface and port, as shown in Figure 6 on page 63. This capability is essential for sending multicast traffic to hosts that cannot report their group membership with IGMP. It plays an important role in video over ADSL applications.

Figure 6 on page 63 illustrates a switch forwarding the multicast stream to a set-top box after a user specifies that group 224.1.1.1 multicast data should be forwarded out of port 4 of VLAN1.
